RECONNAISSANCE PRESERVATION ASSESSMENT FOR MEMORY HILL CEMETERY, CITY OF MILLEDGEVILLE, GEORGIA

Chicora Research Contribution 445

Prepared By:
Michael Trinkley, Ph.D.

May 31, 2006

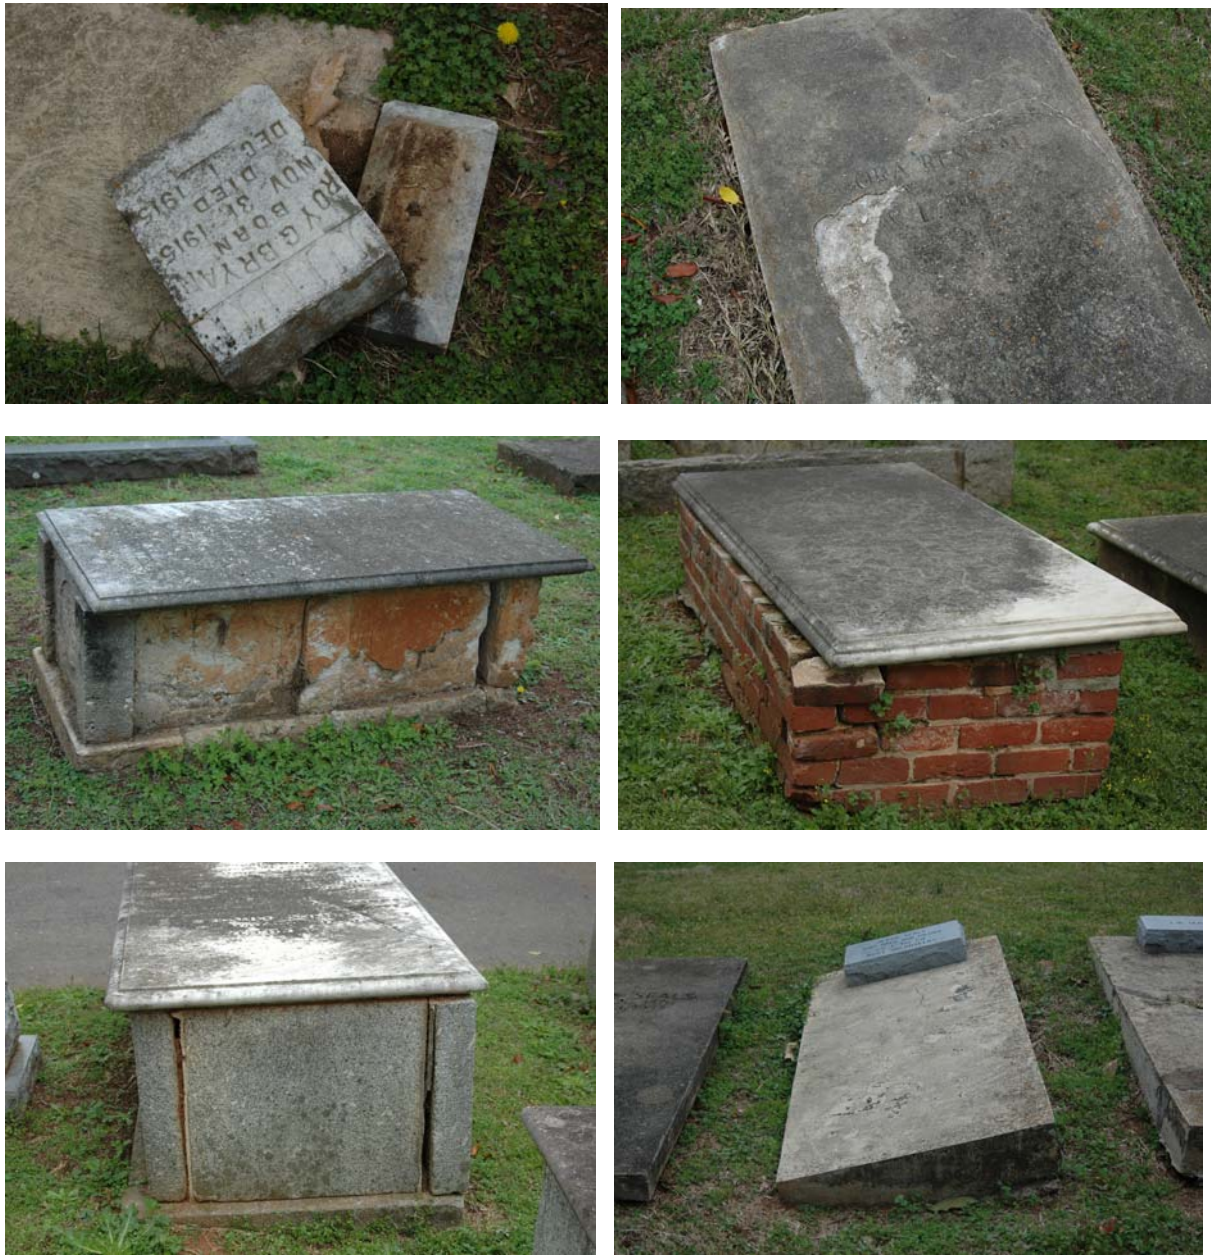
Figure 43. Typical monument damage. The upper left stone shows a corroded ferrous pin. This pin will need to be core drilled out and replaced with a stainless steel pin. The upper right photograph illustrates a spalling concrete ledger. Loss of this fabric will make the stone unreadable. The middle left photograph shows a badly spalling sandstone box tomb. The middle right photograph shows a failing brick box tomb and partially displaced marble ledger. The lower left photograph illustrates a failing granite box tomb. The lower right photograph illustrates a sinking concrete ledger. Like the previous example of a sinking box tomb, this ledger will need to be jacked up and stabilized with a new foundation.
